SEDIMENT DYNAMICS OF AN IMPOUNDED RIVER:
YEGUA CREEK, TEXAS

A Thesis

Submitted to the Office of Graduate Studies of
Texas A&M University
in partial fulfillment of the requirements for the degree of
MASTER OF SCIENCE

May 2008

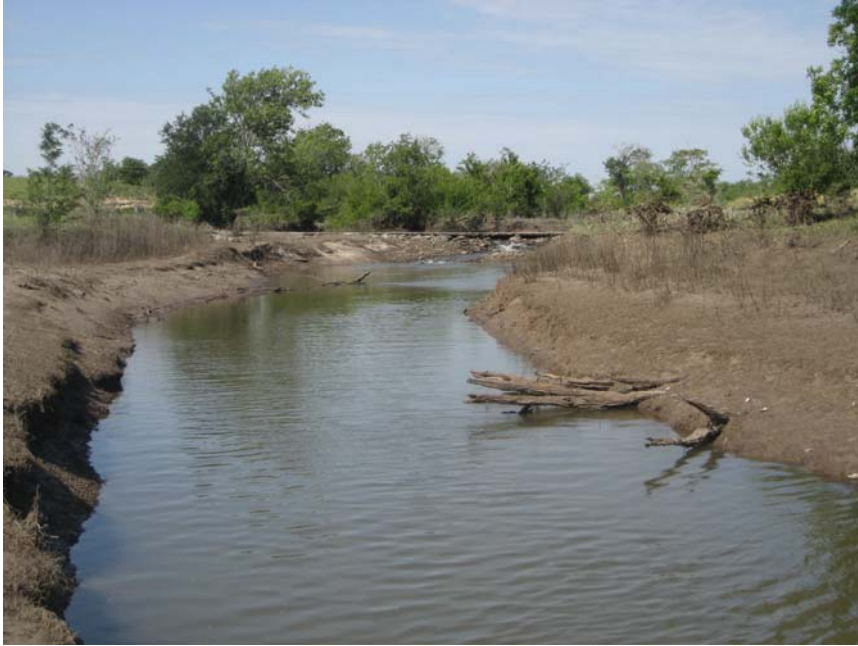
Fig. 14. Yegua Creek downstream Somerville Dam.

Evidence of this phenomenon is found along Yegua Creek as well. Banks at the Highway 36 cross section of Yegua Creek are highly vegetated and unlikely to be erosive (Fig. 14). However, banks along the Landolt cross sections, where suspended sediment is highest, are mostly free of vegetated material (Fig. 15). The lack of vegetation could account for easily erodable banks and therefore, an increase in suspended sediment concentrations.

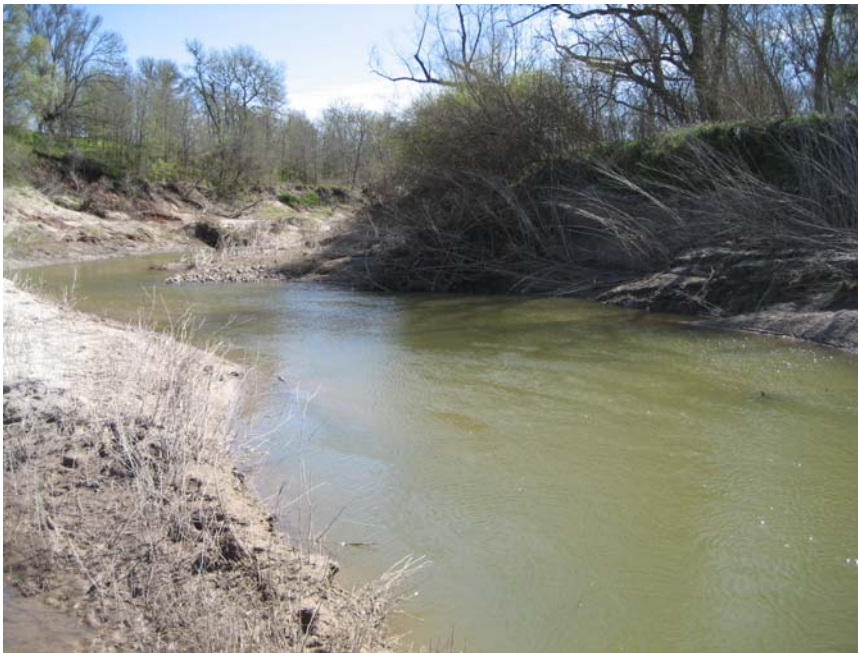
Fig. 15. Yegua Creek, Landolt Cross section B (Fig. 17), Spring 2007.

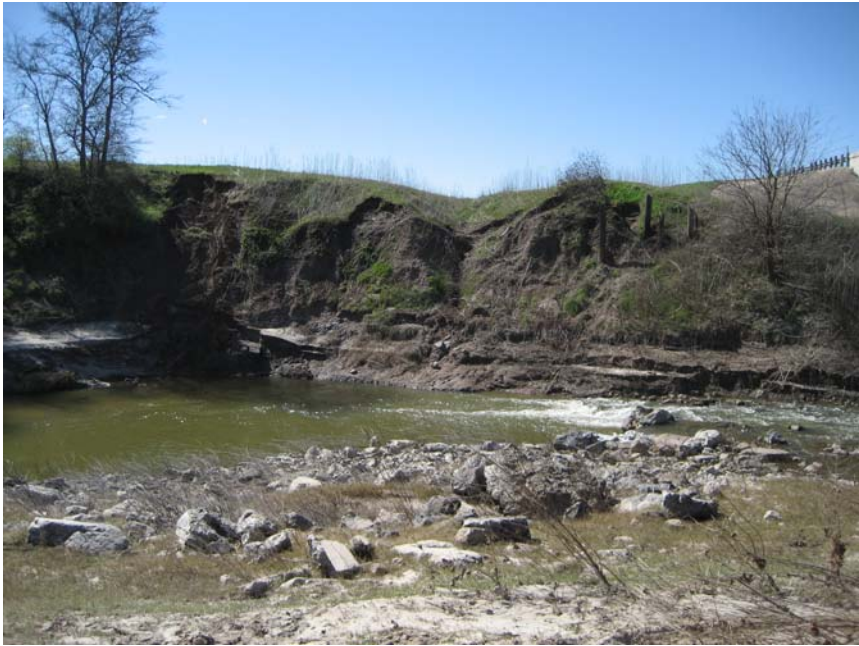
Fig. 17. Unstable banks visible on Yegua Creek at Highway 50 crossing.

The characteristics of the channel morphology of Yegua Creek are as follows. The average channel slope throughout the basin is 0.0001. This slope value is consistent with coastal plain streams. Upstream of Lake Somerville, average width and depth are 13.1 m and 0.36 m, respectively. Downstream of Lake Somerville, the width and depth average 22.4 m and 0.65 m, respectively. The bed material consists of primarily fine grained, cohesive sediment (Chin et al., 2002). Field observations provided preliminary evidence of substantially coarser bed material throughout West Yegua Creek (Fig. 10), Nails Creek (Fig. 11) and lower Middle Yegua Creek (Fig. 8). Banks along Yegua Creek and its tributaries throughout Yegua Creek drainage basin are primarily stable. One notable exception is the eroding banks near the intersection of Yegua Creek and Highway 50 downstream of Somerville Dam (Fig. 17).

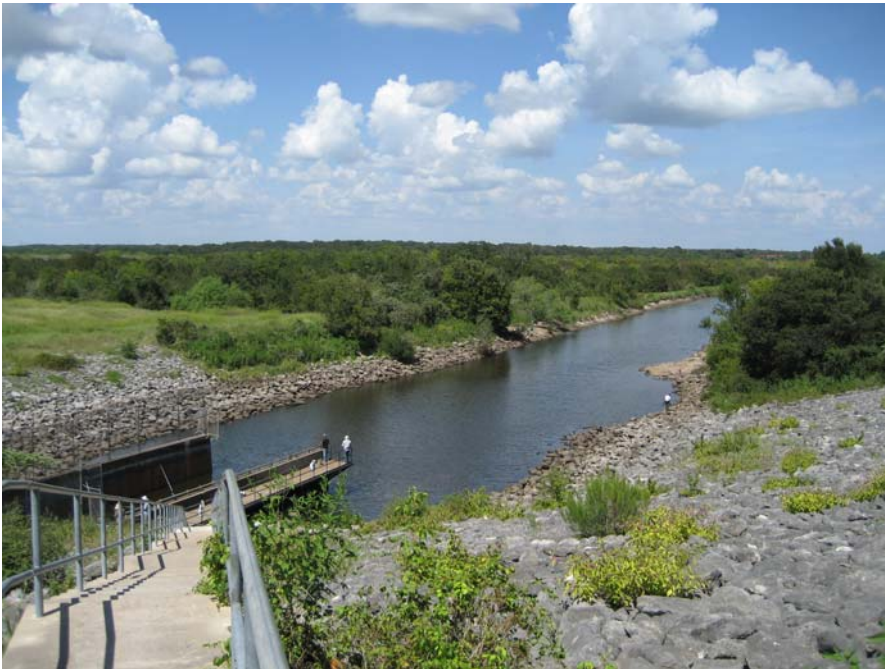
Fig. 18. Somerville Dam outlet and Yegua Creek.

Construction of Somerville Dam on Yegua Creek began in early 1963; the dam started impounding water in 1967 (Fig. 18). The chief purposes of the dam are to control flooding on Yegua Creek, conserve water, and attract visitors to the area (Schaffer, 1974; Chin and Bowman, 2005). The dam has a life expectancy of 50 years, a conservation storage capacity of 177,498,000 m³ (143,900 ac-ft), and a flood control storage capacity of 416,547,000 m³ (337,700 ac-ft) (Chin et al., 2002). Somerville Dam is a large dam in the classification of the National Inventory of Dams (Chin et al., 2008).

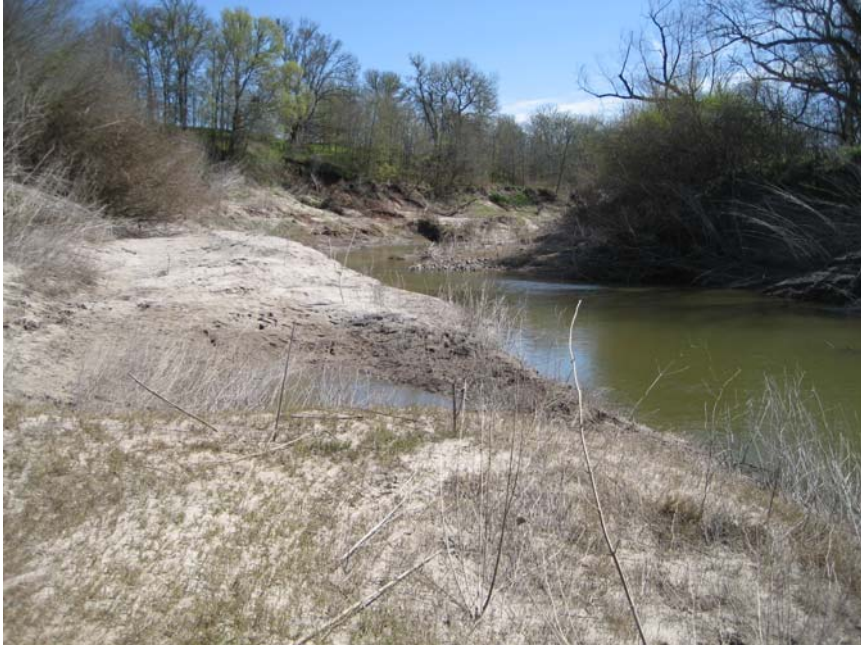
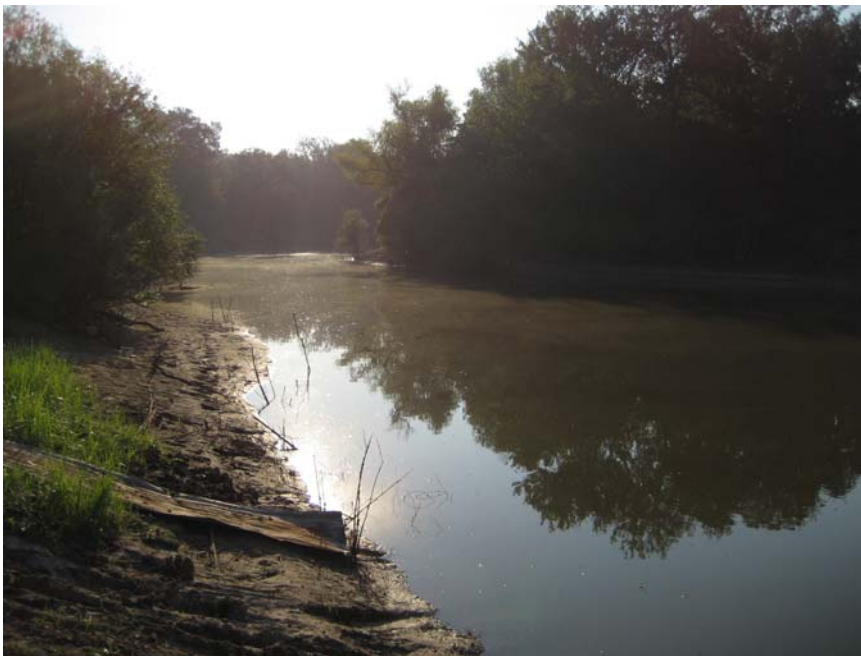
Fig. 45. Yegua Creek depositional feature downstream of Somerville Dam.

Fig. 46. Same location on Yegua Creek after major flood event. Note absence of depositional feature.

Field observations corroborate evidence of deposition and erosion provided by the aerial photographs. Figures 45 and 46 show the same location (Y50DS, Fig. 19), before and after a summer of 2007 flood event. Fig. 45 clearly shows a sand bar on the left edge of water. After a flood event, the absence of the sand bar is clear. This location is depicted in Fig. 47 as an aerial photograph. The sand bar is the depositional feature found in Fig. 45. In addition, the unstable bank showing active erosion is the feature depicted in Fig. 17. Therefore, aerial photographs and field observations support the conclusion that Yegua Creek is actively eroding and depositing sediment downstream of Somerville Dam and is not dominated by one single process regime.

These results corroborate field observations. Figures 45 and 46 show Yegua Creek near its confluence with the Brazos River (Y50DS, Fig. 18 Table 2). Figure 44 shows the creek prior to a flooding event. Note the sand bar located on the left edge of water. Figure 45 is this same location after a flood event. During this June 2007 flood event, dam gates were opened 3 feet, releasing an average of 1,119.1 cfs from the dam (USACE, 2007b). Average discharge released from the dam in 2007 was 568 cfs and

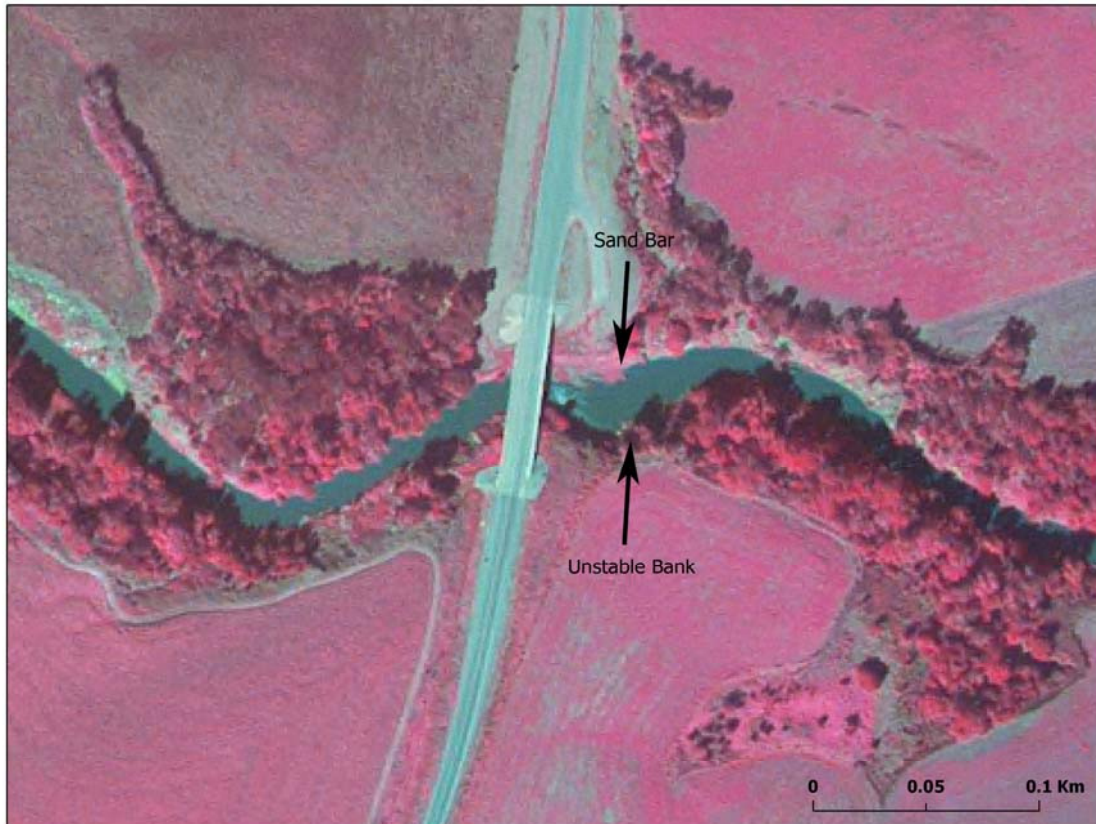
Fig. 47. Y50US cross section.

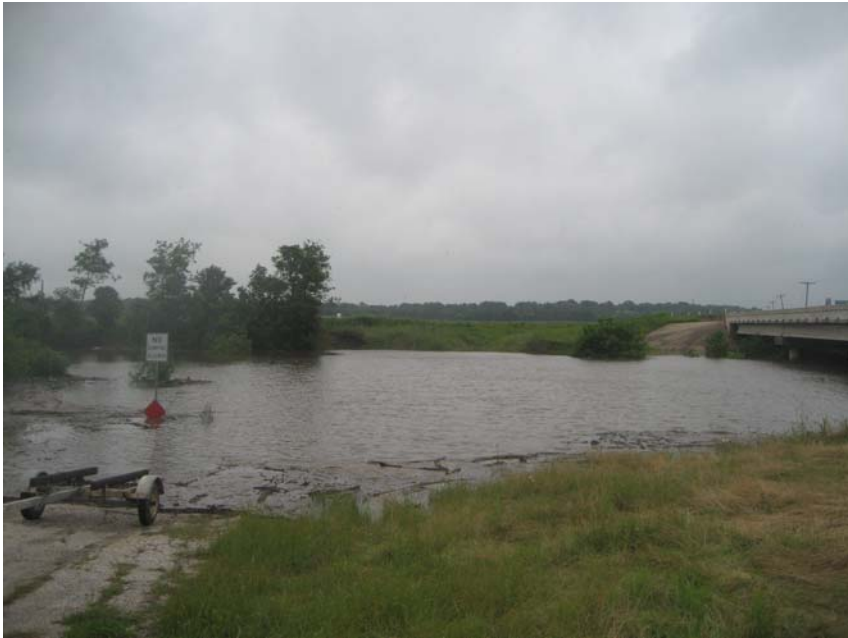
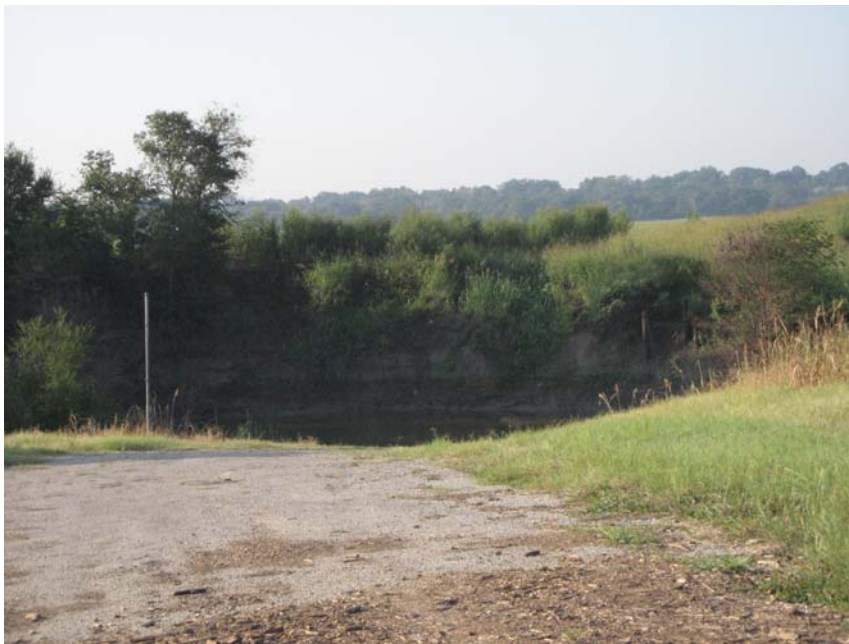
Fig. 49. Yegua Creek during flood event downstream of Somerville Dam.

Fig. 50. Same location after flood event (Note: Sign suffered some damage during event).

Suspended sediment concentrations at high flows along Yegua Creek reiterate the finding that sediment is being transported downstream of Somerville Dam. Fig. 49 and 50 show Yegua Creek at high and low flows, respectively. Sediment concentrations

averaged 26 ppm downstream of Somerville Dam at high flows. These concentrations occurred at an average discharge of 15.48 cms. Therefore, high flows produced by the dam have the ability to transport sediment.
